SITE INSPECTION

ANALYTICAL RESULTS REPORT

UPPER ANIMAS WATERSHED (CERCLIS ID # CO0001411347)

SAN JUAN COUNTY, COLORADO

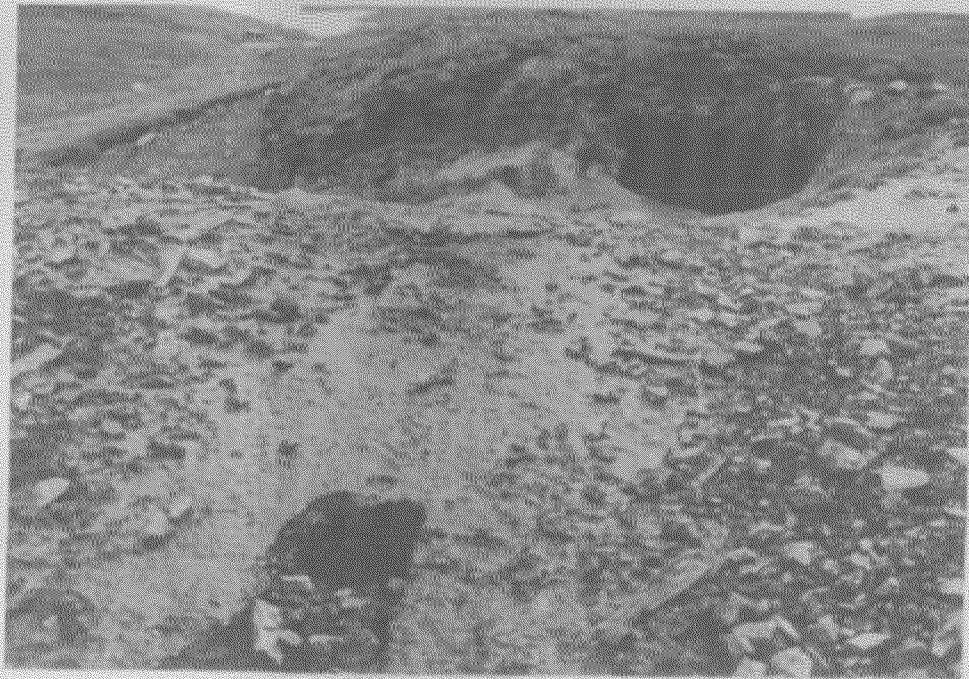
Description of Photo: SO-2 Portal and Mine drainage (note fencecrete).

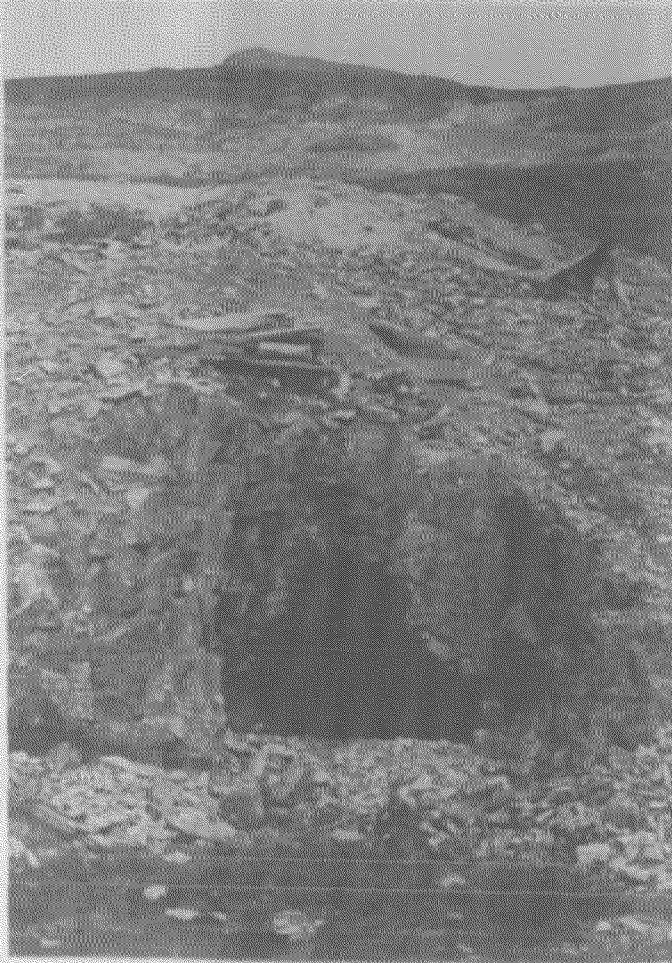
Description of Photo: SO-7 Mine Portal
Date: August 12, 1997 Time: 1130
Direction facing: North (35mm film)

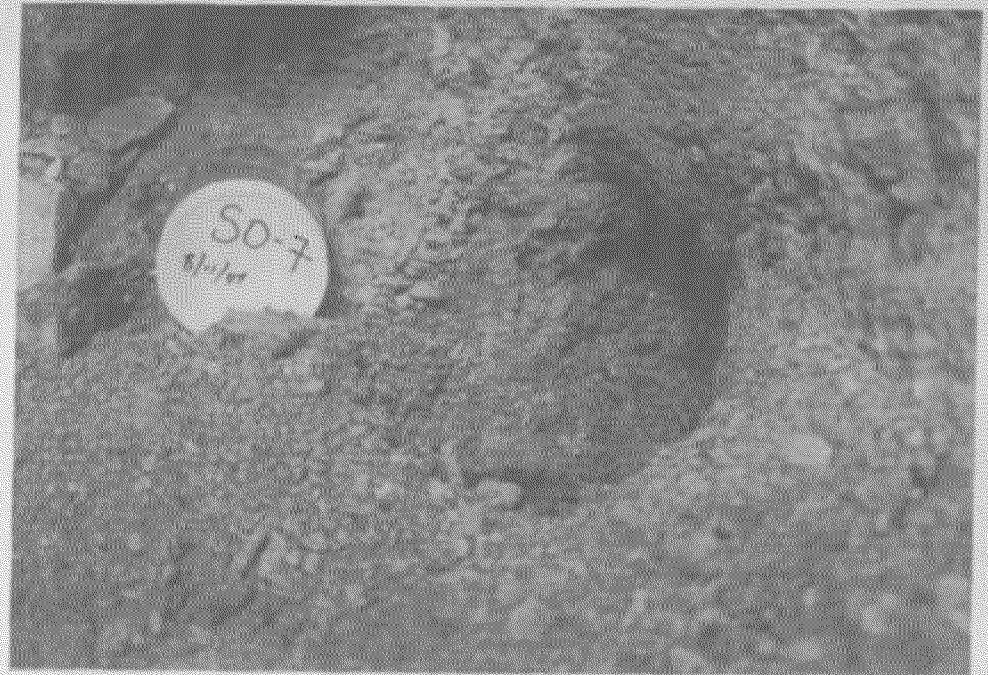
Description of Photo: SO-7 Mine Waste sample
Date: August 12, 1997 Time: 1130
Direction facing: North (35mm film)

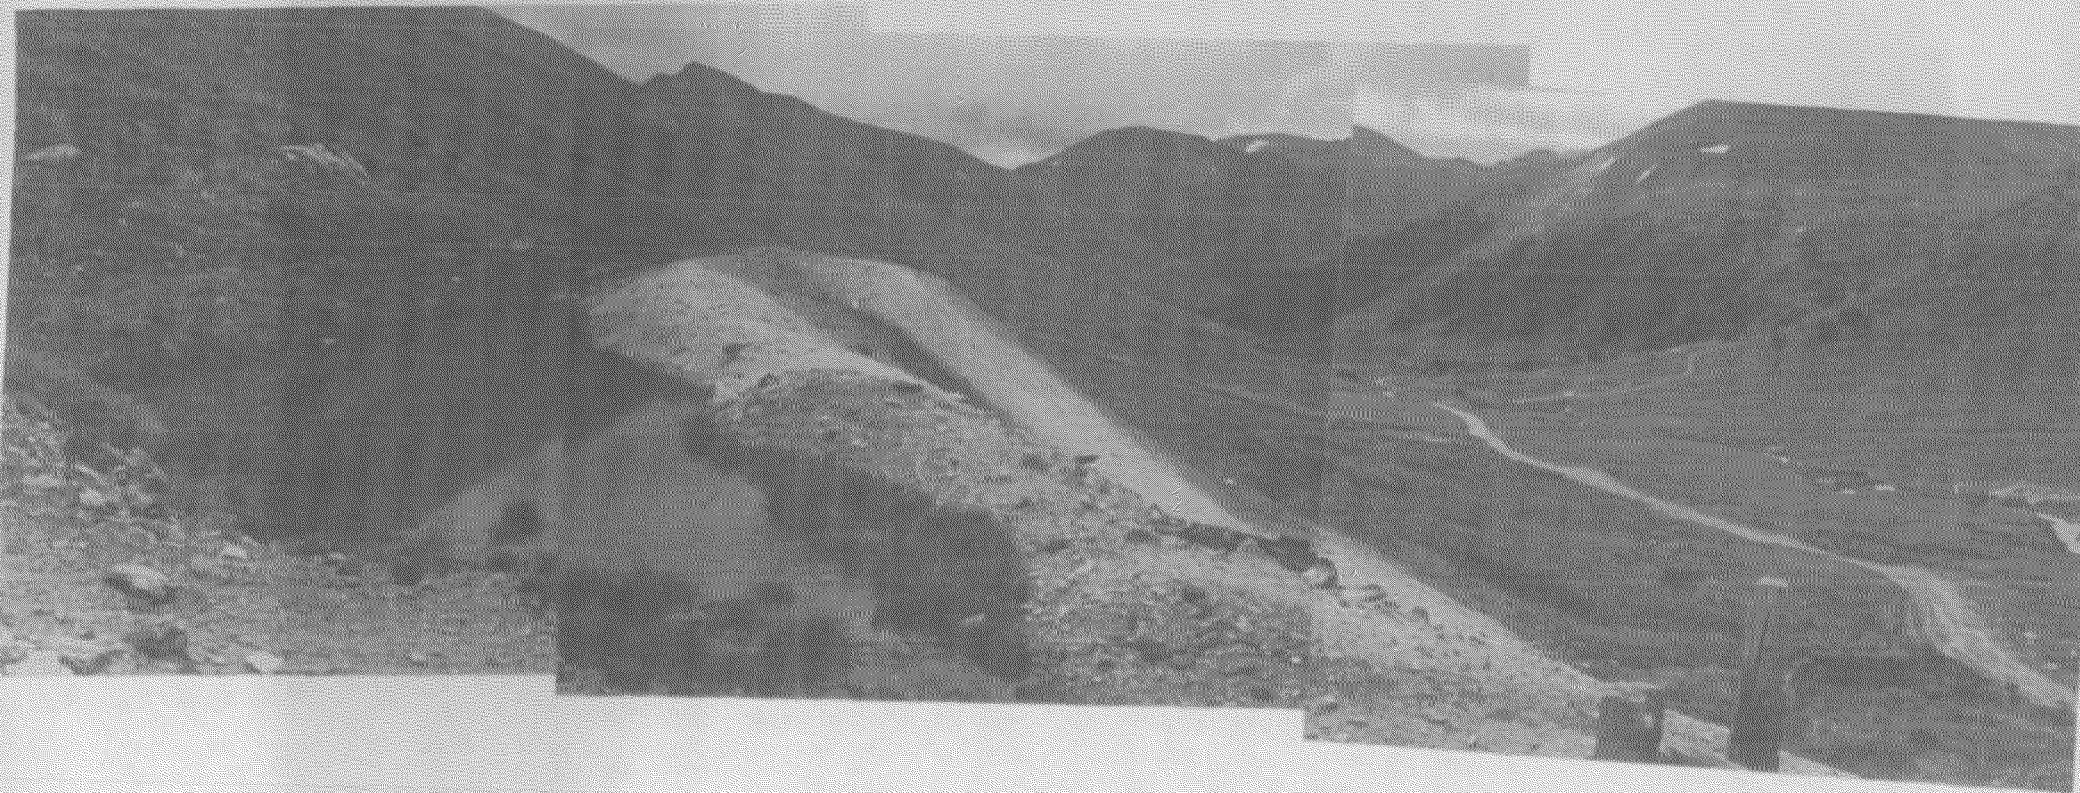
Description of Photo: SO-G Mine waste pile.
Date: August 11, 1997
Direction facing: Southeast (35mm film)

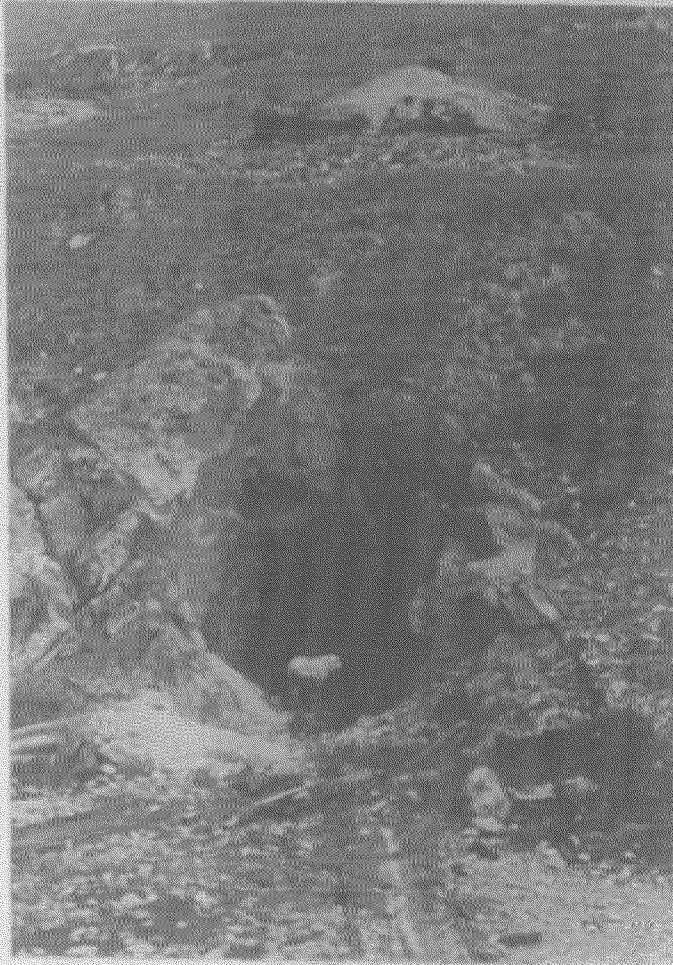
Description of Photo: SO-8 Mine Portal
Date: August 11, 1997 Time: 1130
Direction facing: North (35mm film)

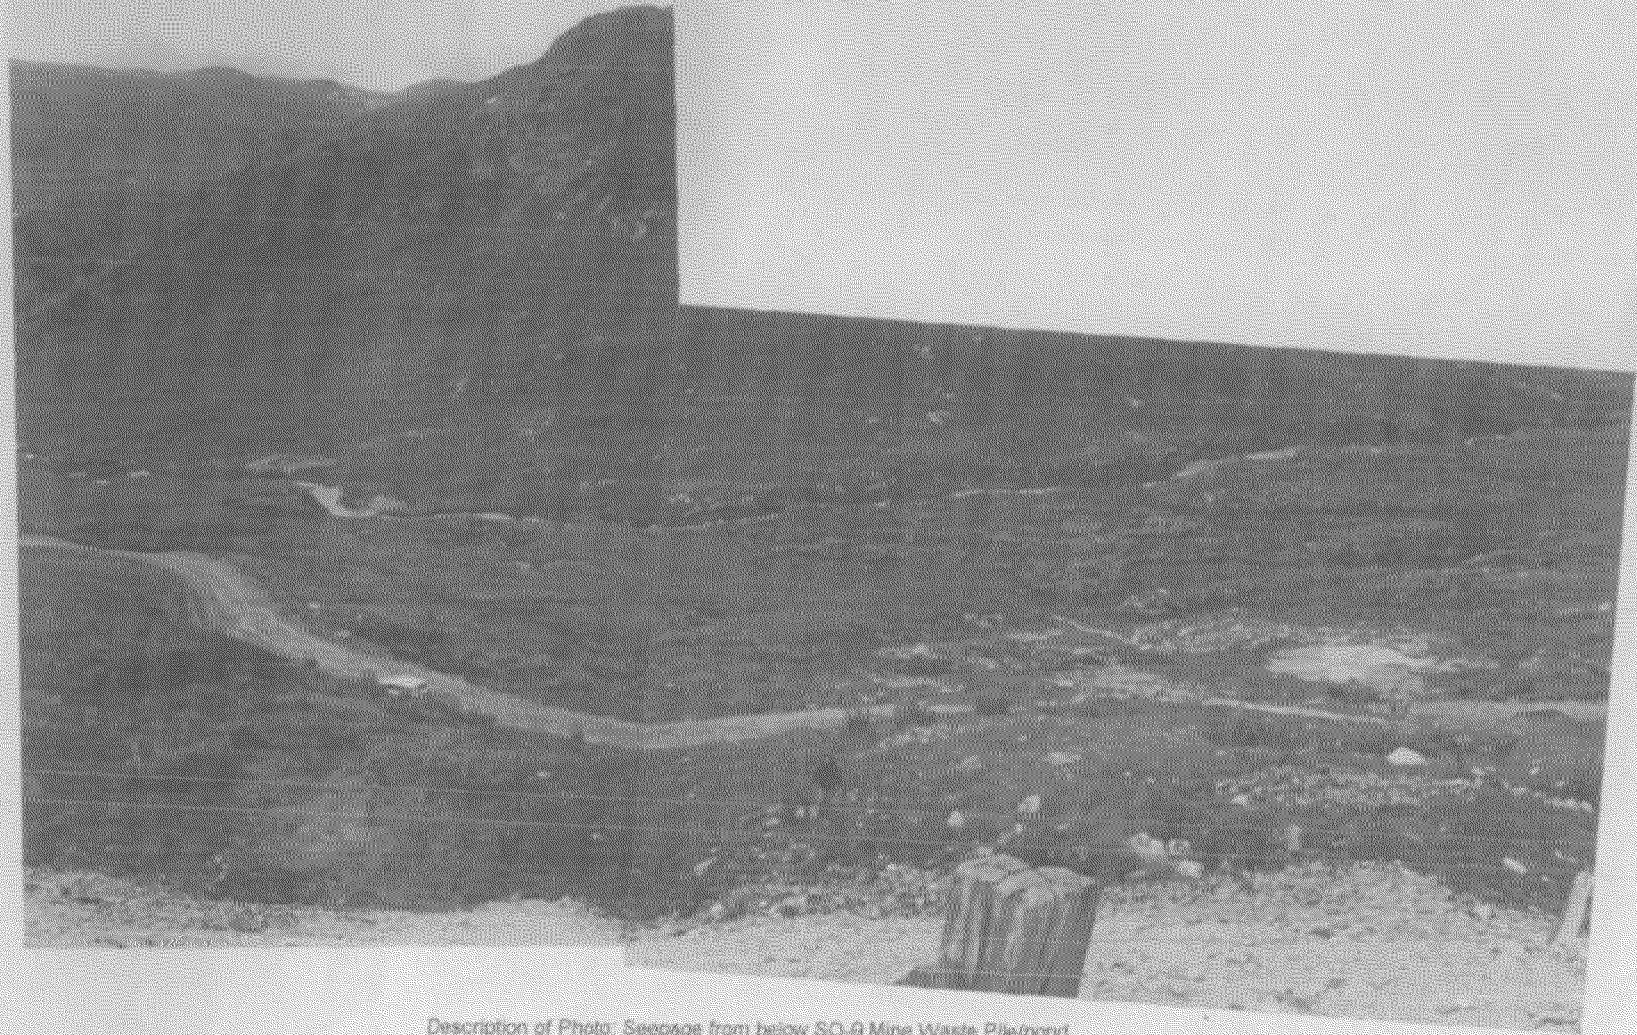
Description of Photo: Seepage from below SO-G Mine Waste Pile/pond
Date: August 11, 1997 Time: 1200
Direction facing: Southeast (35mm film)

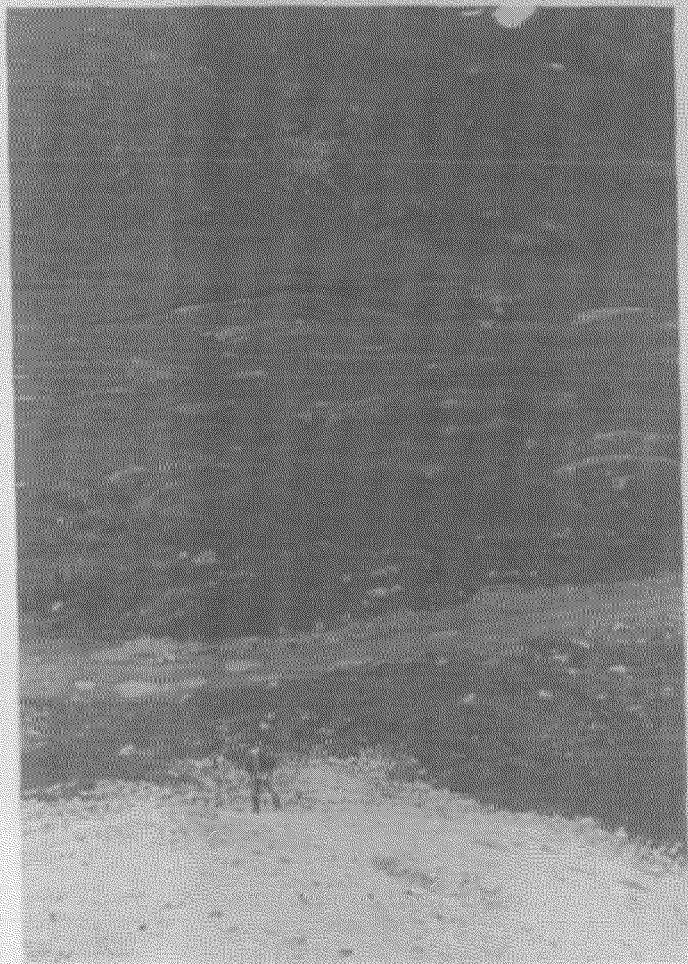
Description of Photo: SO-8 Mine Waste Pile.
Date: August 11, 1997 Time: 11:45
Direction facing: South (35mm film)

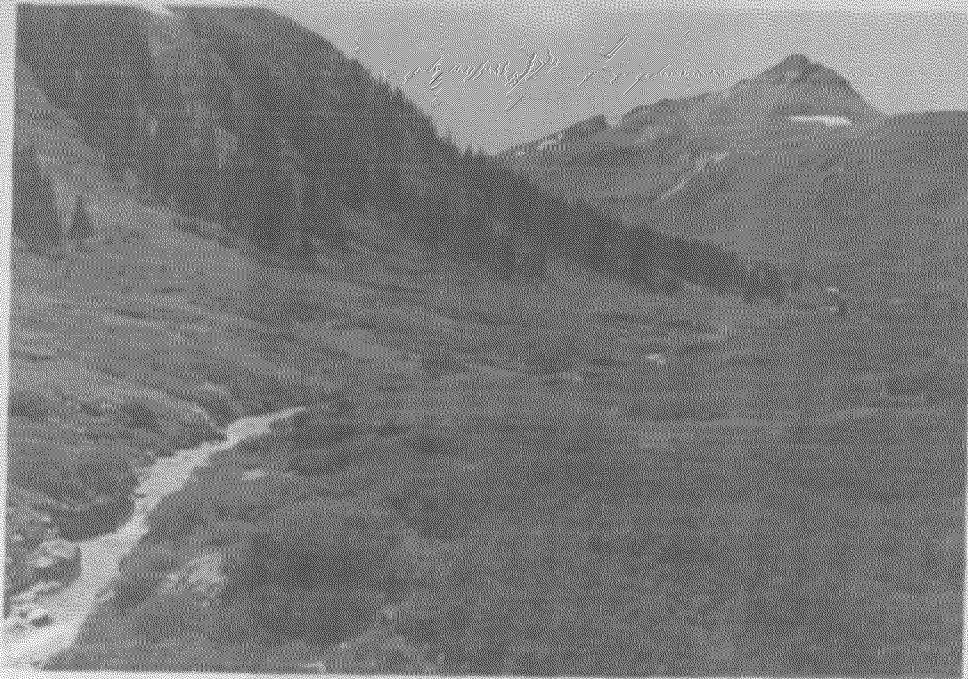
Description of Photo: SO-10 Looking west of Bagley T. Waste Pile.
Date: August 11, 1997 Time: 1315
Direction facing: West (35mm film)

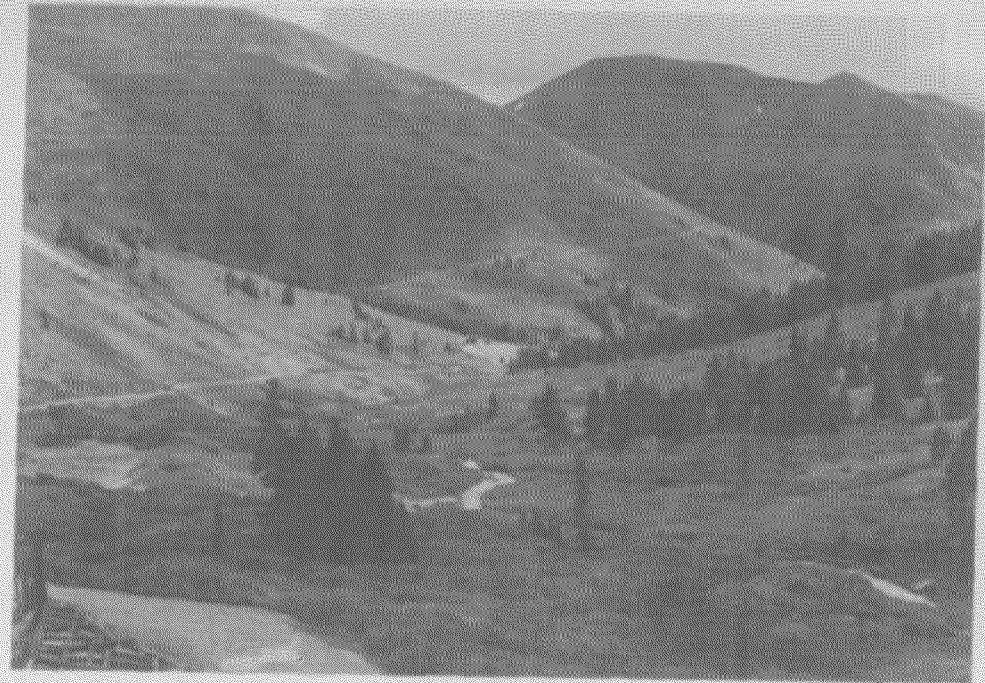
Description of Photo: SO-10 Looking east of Bagley T. Waste Pile.
Date: August 11, 1997 Time: 1315
Direction facing: East (35mm film)

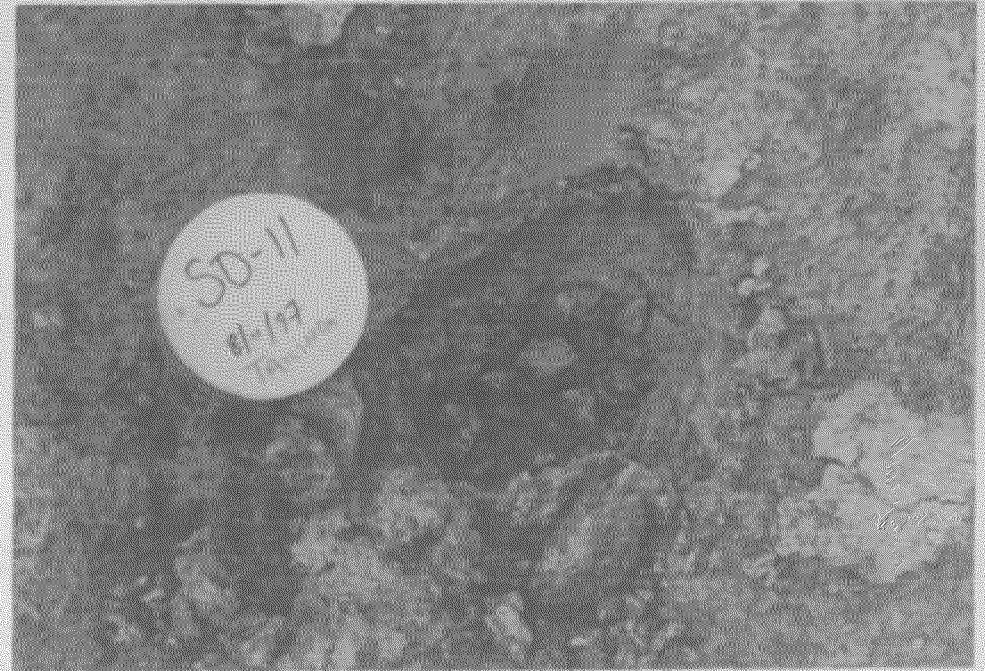
Description of Photo: SO-11 Bagley T. Tailing Pile sample.
Date: August 11, 1997 Time: 1315
Direction facing: East (35mm film)

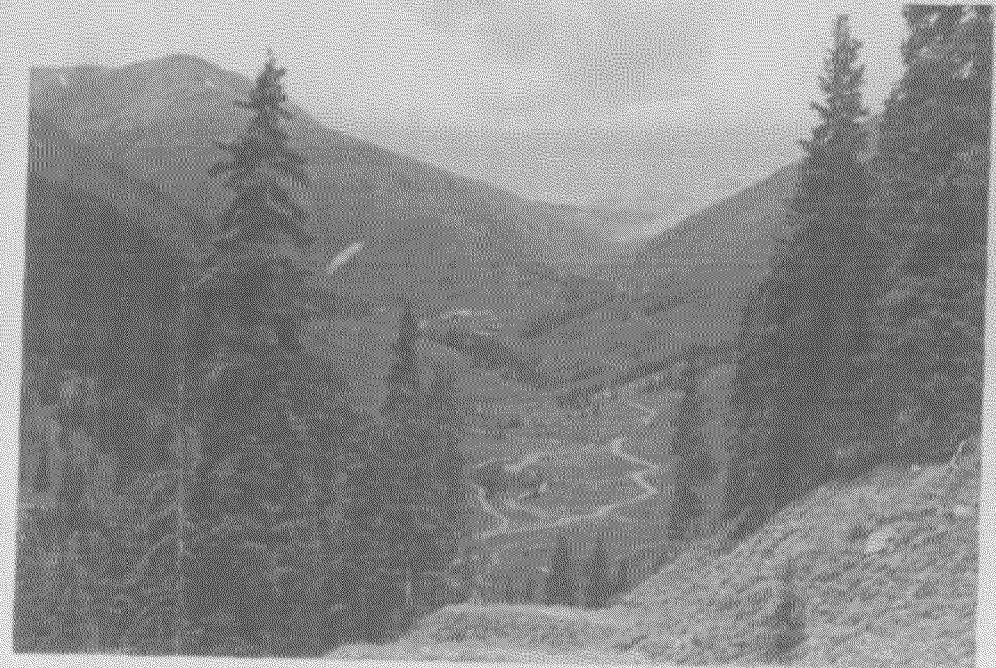
Description of Photo: SO-13 Columbus Mine Waste Pile at Animas Forks.
Date: August 11, 1997 Time: 1315
Direction facing: North (35mm film)

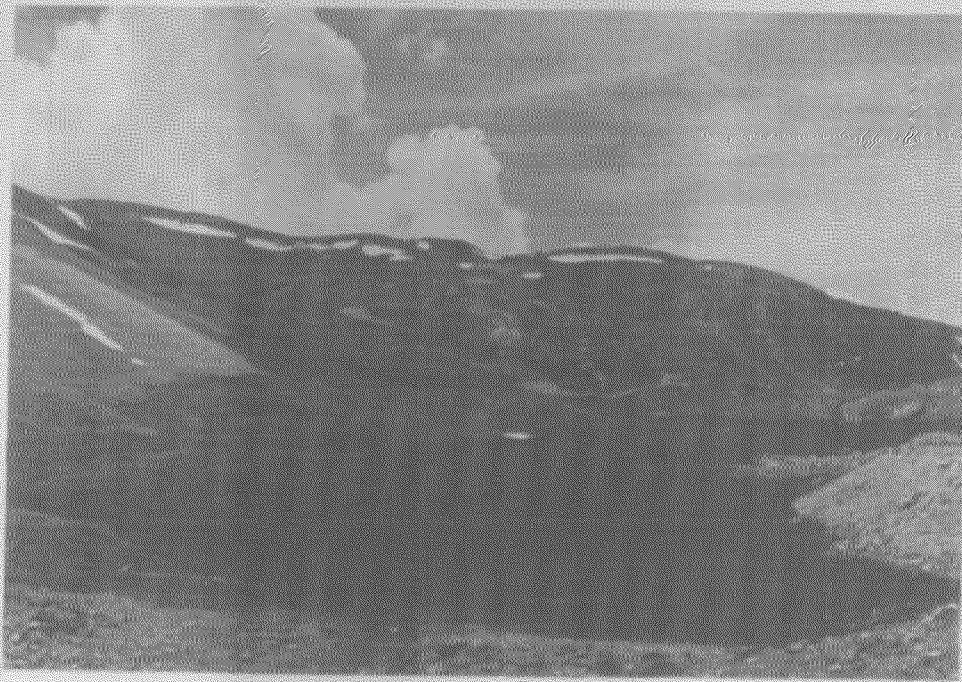
Description of Photo: SO-21 and 22 Mine Waste Piles in Burrows Gulch.
Date: August 12, 1997 Time: 1200
Direction facing: West (35mm film)

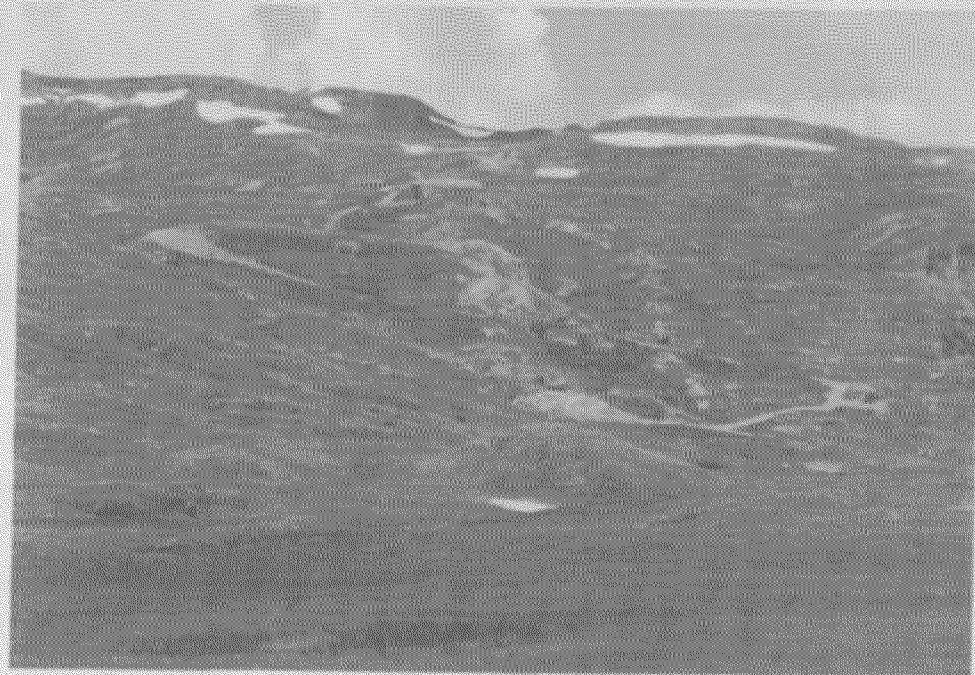
Description of Photo: SO-21 and SO-22 Mine Waste Piles in Burrows Gulch.
Date: August 12, 1997 Time: 1215
Direction facing: West (35mm film)

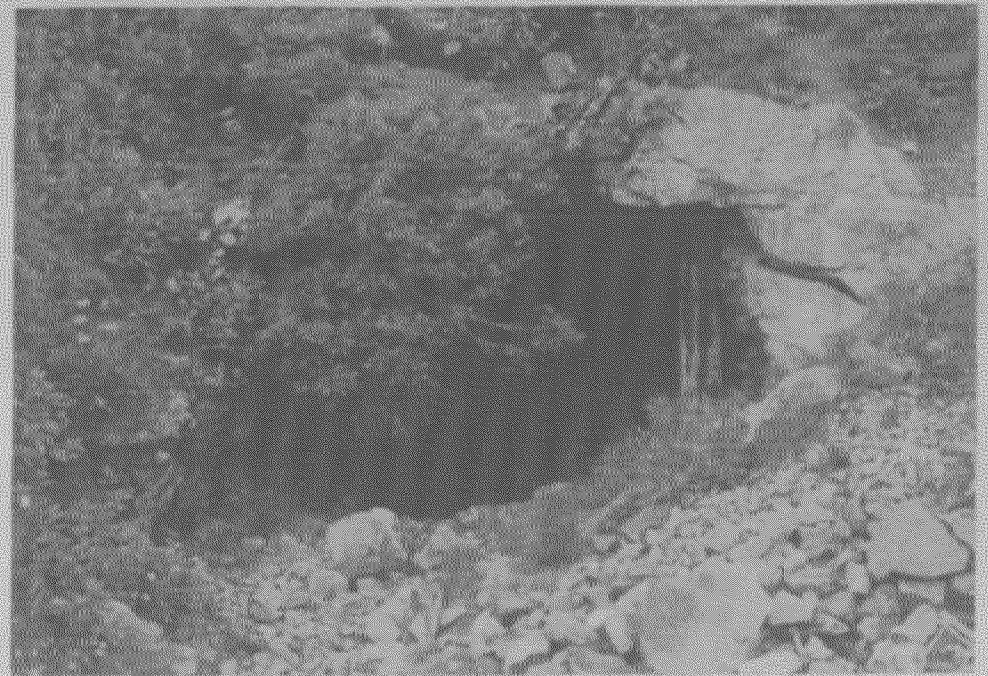
Description of Photo: SO-26 Mine portal
Date: August 12, 1997 Time: 1545
Direction facing: West (35mm film)

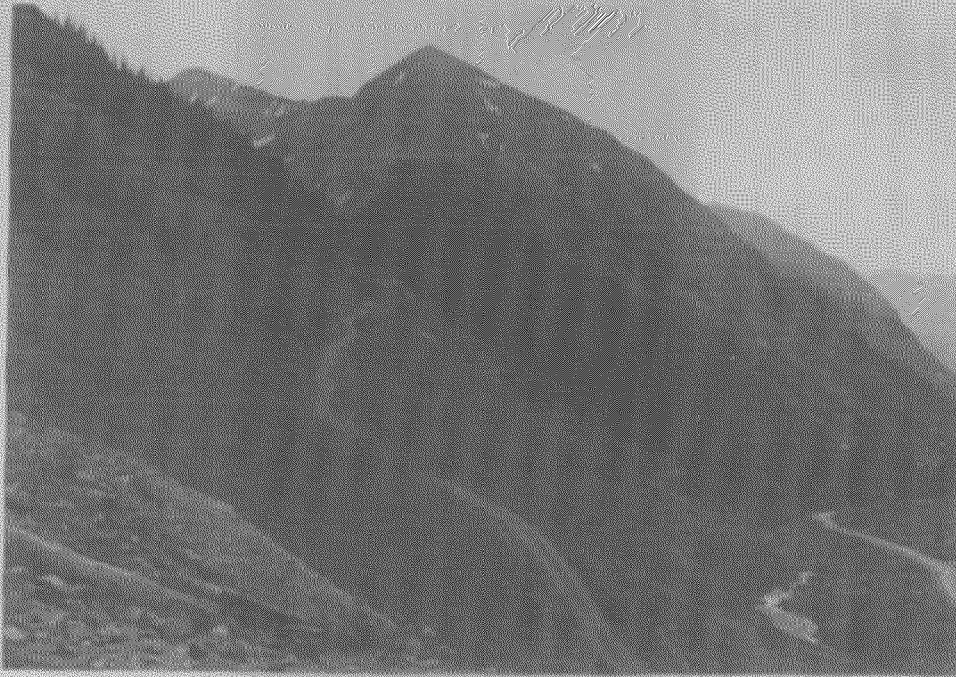
Description of Photo: SO-29 Mine Waste Pile
Date: August 13, 1997 Time: 1130
Direction facing: Southeast (35mm film)

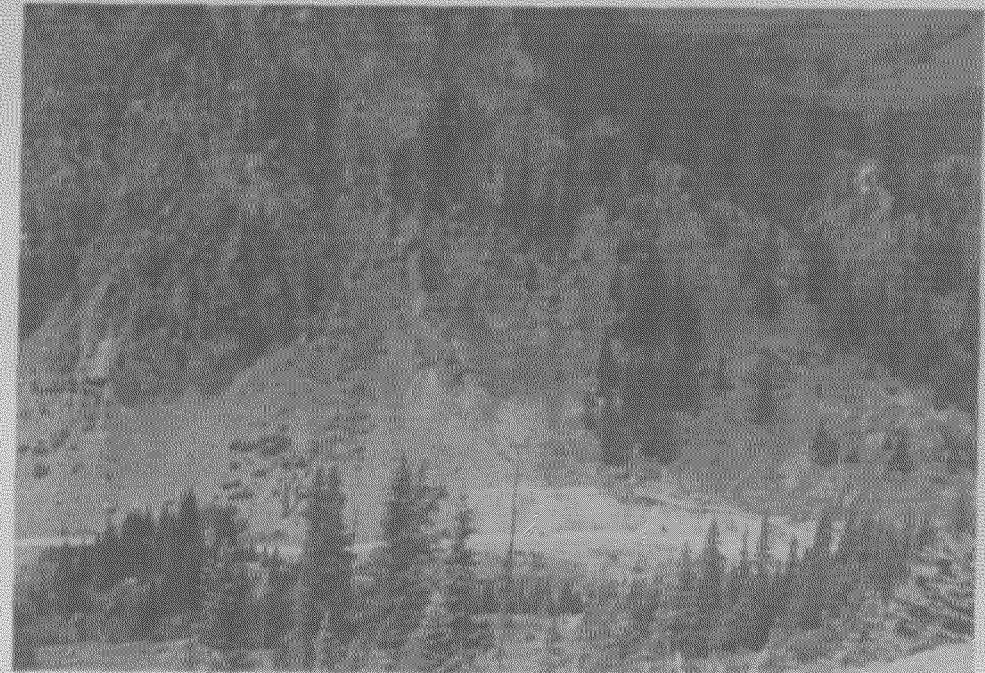
Description of Photo: SO-30 Mine Waste Pile
Date: August 13, 1997 Time: 1230
Direction facing: Northwest (35mm film)

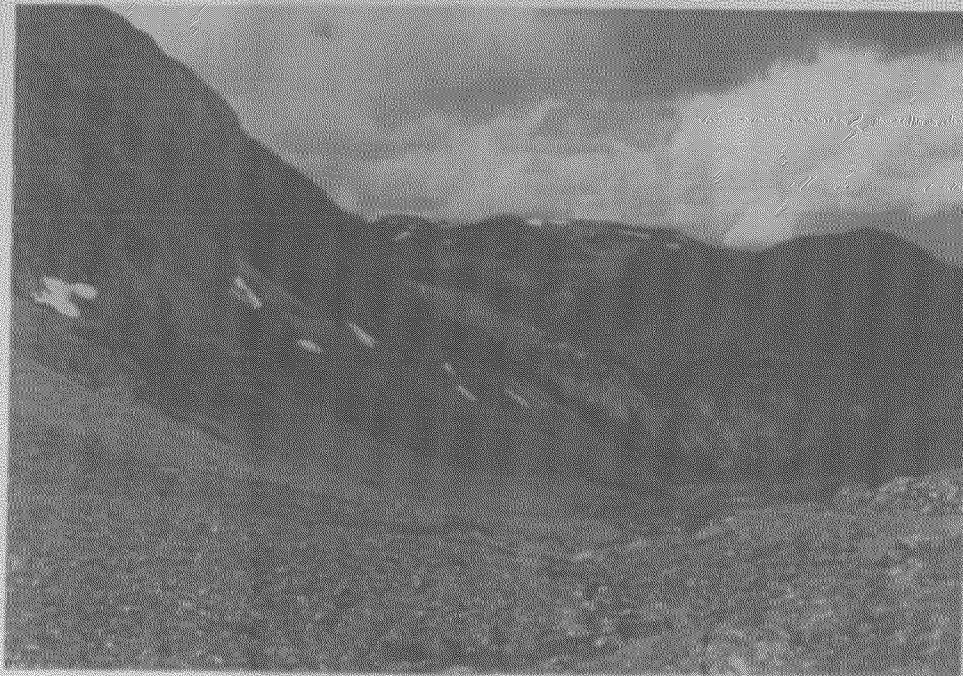
Description of Photo: SO-34 Mine Waste in Burns Gulch.
Date: August 13, 1997 Time: 1500
Direction facing: Northwest (35mm film)

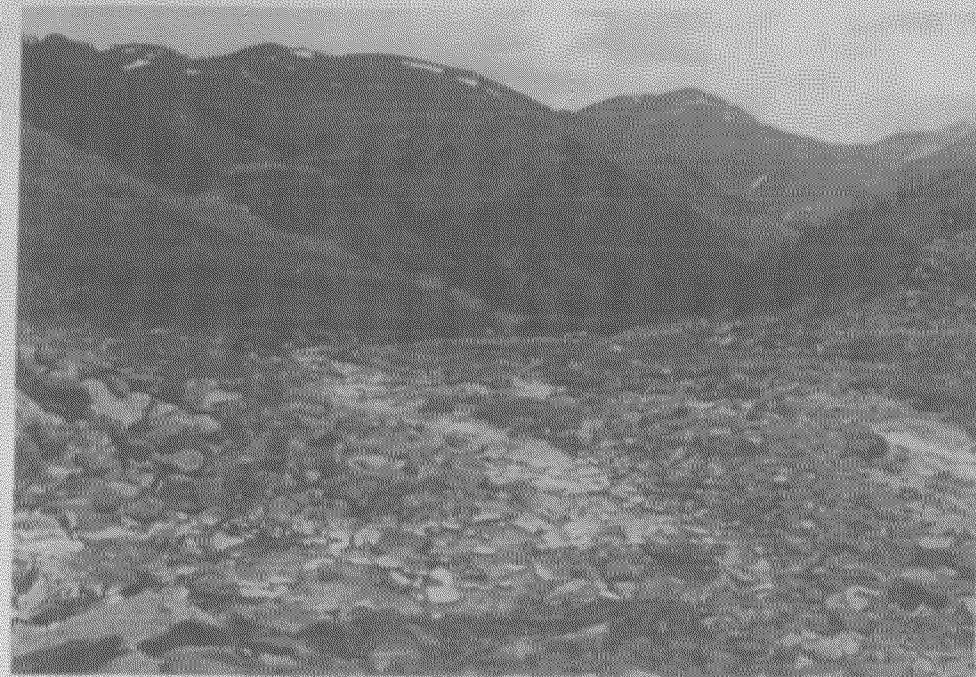
Description of Photo: OP-SE-100 Spring with white precipitate in Burns G.
Date: August 13, 1997 Time: 1330
Direction facing: Northwest (35mm film)

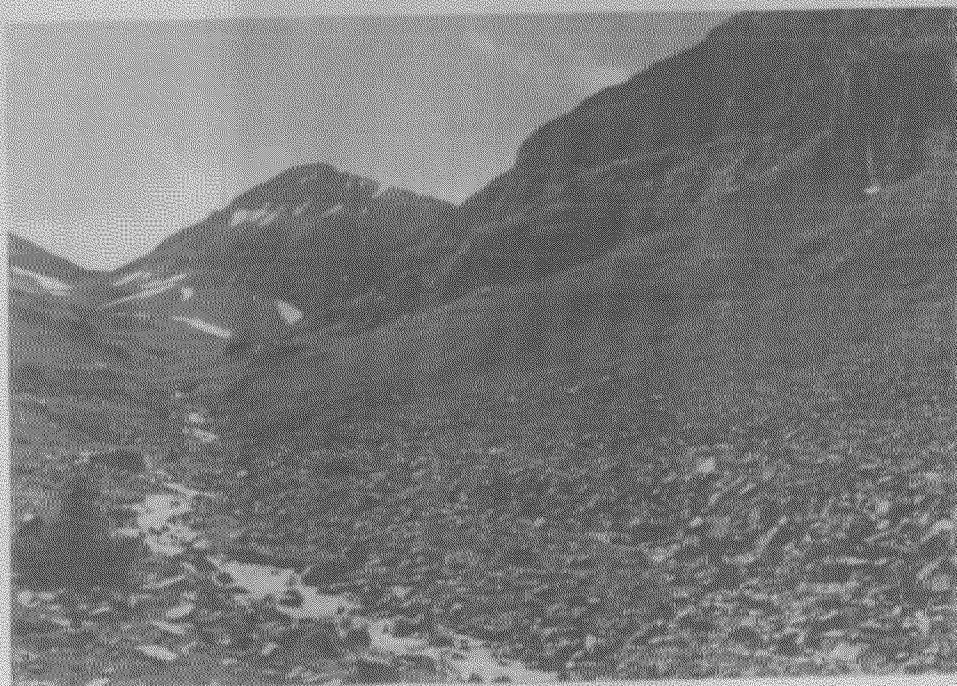
Description of Photo: OP-SE-100 Talus slope from which spring originates.
Date: August 13, 1997 Time: 1300
Direction facing: Southwest (35mm film)

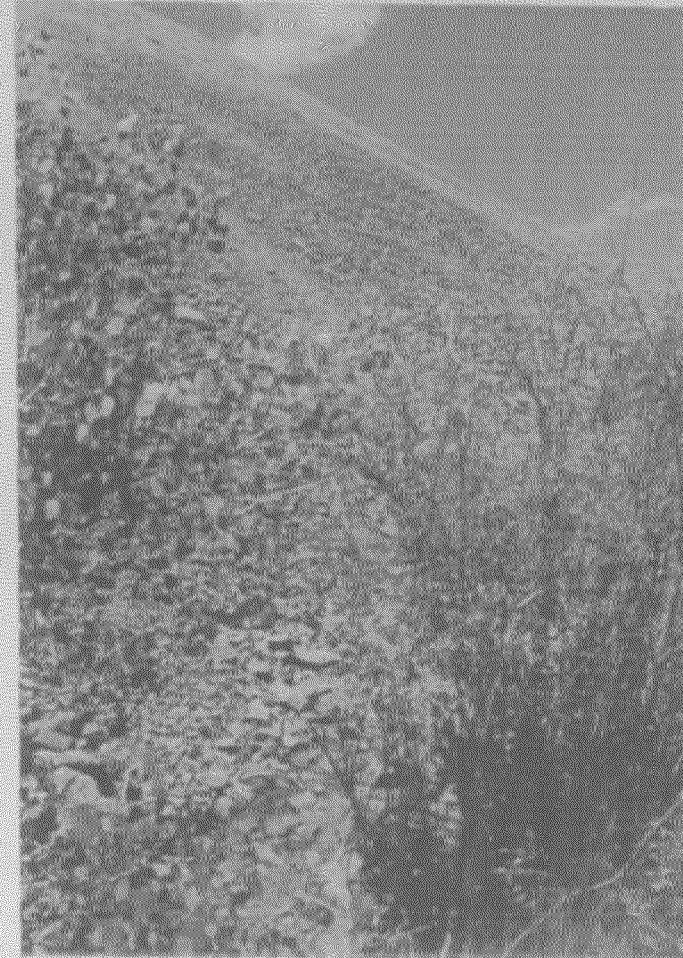
Description of Photo: SO-38 Eureka Mill Mine drainage
Date: August 13, 1997 Time: 1430
Direction facing: Northeast (35mm film)

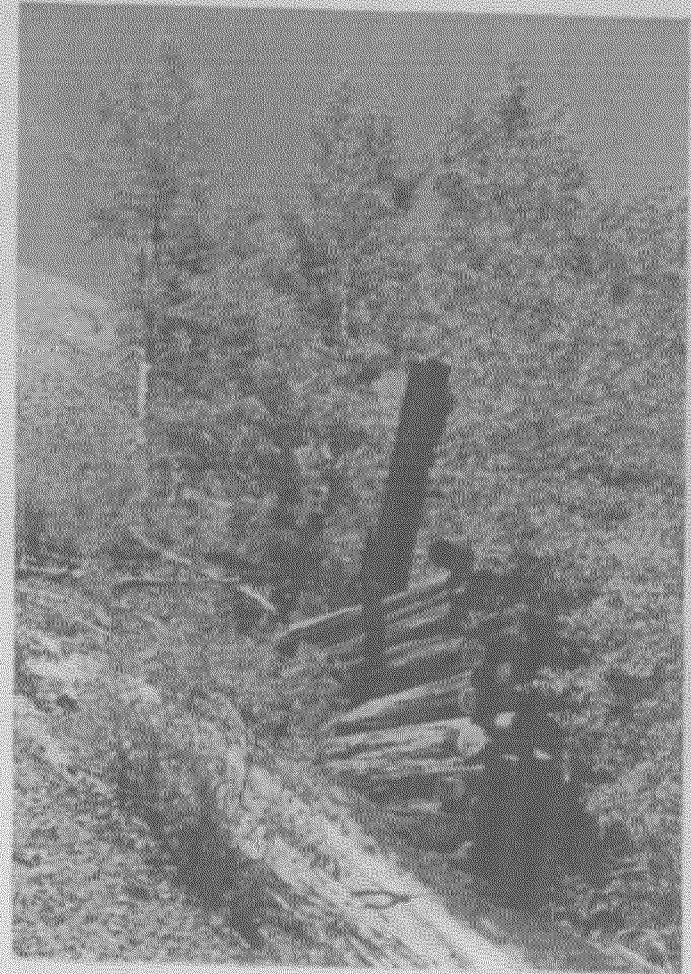
Description of Photo: SO-36 Eureka Mill Mine drainage
Date: August 13, 1997 Time: 1000
Direction facing: Northeast (35mm film)
